CHALLENGE

A major North Sea operator had a SSSV that had been inoperable and the well had been shut in for several years. The SSSV flapper was stuck in a partially open position and it would not close or pass an inflow test. There was also a Wireline brush stuck below the SV flapper at an unconfirmed depth. Calcium Carbonate scale was seen in the flow tube area and in the tubing above the SSSV.

Norwegian North Sea

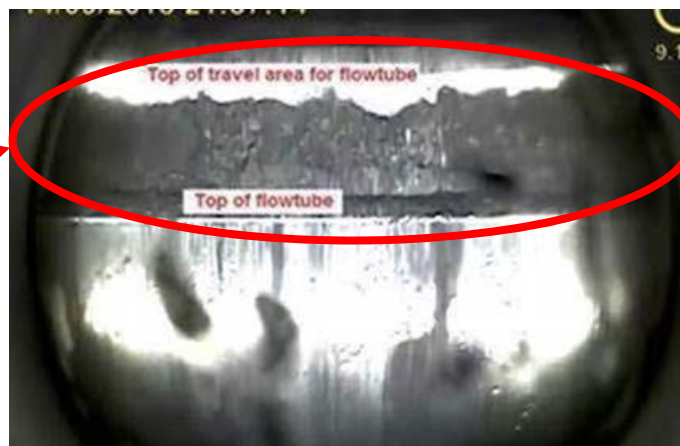
Scale formed on top of flow tube

Photo provided by Operator

- An increase in control line returns was noted after the 1st WASP[®] run, indicating the flow tube and flapper were reactivated
- A successful inflow test was performed on the SSSV after the 2nd run
- Subsequently, the Wireline Brush was fished from beneath the SSSV, the well was perforated in 2 new zones and brought back online
- Production was commenced after being shut-in for several years

Remove CaCO₃ scale from the SSSV to restore functionality using electro-hydraulic pulsing technology

- The Blue Spark WASP[®] 275 (Wireline Applied Stimulation Pulsing) tool was run on third-party E-Line with a No-Go so as not to contact the flapper
- The flow tube was cleaned during the first run in the well (the flow tube was now moving)
- The No-Go was removed and a second run was made to treat the flapper directly, as well as the entire length of the SSSV
