TECHNICAL PUBLICATION

Title: Cleaning Scale from Upper Completion Equipment with EHP

Author: Mike Perri, P.Eng, Blue Spark Energy Inc.

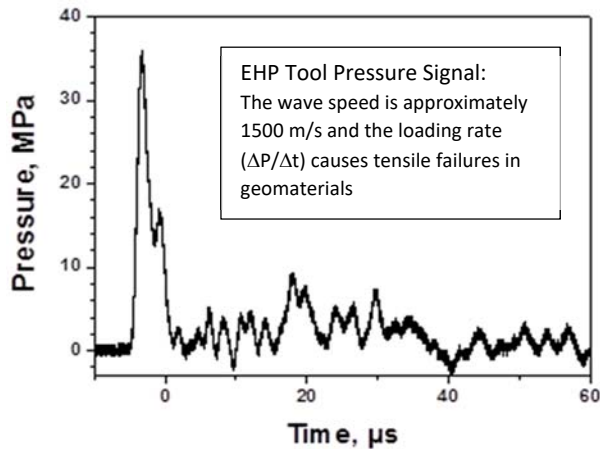
Figure 4. Shock Wave/Pressure Characteristics of an EHP tool at a distance of 15 cm (6 in) from the point source. A very sharp peak is seen that is approximately 5 microseconds wide. The peak pressure is 35 MPa (5,000 psi) at 15 cm (6 in).

time frame, a large amount of power can be generated and released, creating a shock wave and a pressure pulse (Figure 4). These two forceful mechanisms can dislodge material in the wellbore that may be coating casing, tubing, or upper completion equipment. Due to the speed of the energy release, tremendous power can be generated from a relatively modest amount of energy.

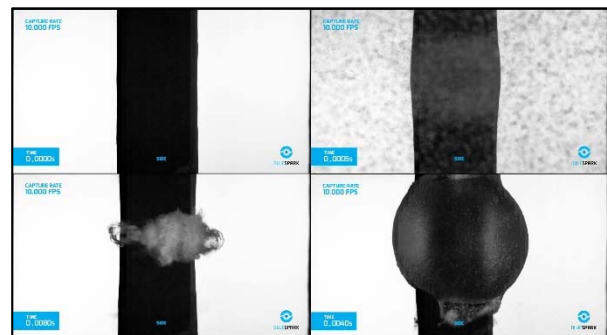
Figure 6. Clockwise from top-left, high-speed photos of an EHP tool pulsing, showing the creation and subsequent collapse of a cavitation bubble.

A secondary effect of an EHP tool is cavitation. Due to the short time-frame of the EHP tool pulse, cavitation can occur in the liquid immediately adjacent to the tool, creating a second shock wave when the bubble of gas

collapses (Figure 6). If the wellbore conditions are such that cavitation can take place, this effect further aids in removing scale from the wellbore. Like the initial shockwave and the pressure pulse, the effect from the cavitation does not directly contact the equipment being cleaned such as with a brush and is therefore potentially less damaging to sensitive equipment.

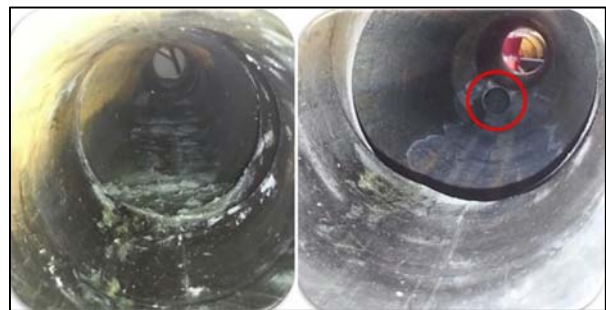
Figure 8. Removal of concrete from a Side Pocket Mandrel (SPM) showing the concrete on the left, and the cleaned SPM with the opening visible on the right.

covered with a thick coat of concrete over the opening, including the valve seat. The concrete was easily cleaned by the EHP tool, leaving an undamaged, fully functional SPM (Figure 8). One of the advantages of EHP is that it does not damage equipment.

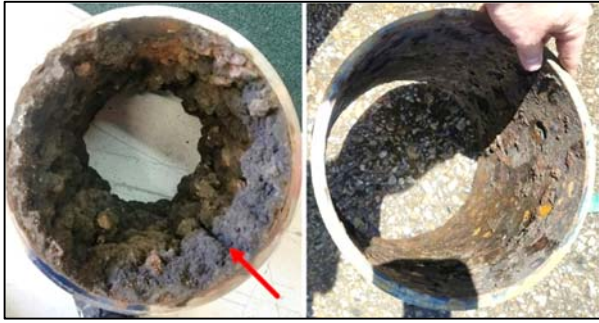
Figure 9. Removal of iron carbonate scale (FeCO_3) from 9-5/8" casing using EHP. The photo on the left shows the scale, including where an attempt was made to remove scale with a hammer and screwdriver (red arrow). The photo on the right shows the piece of casing after only 120 pulses.

Occasionally a customer will provide equipment with scale buildup for testing, although this is generally only available for tubulars. One customer provided a piece of 9-5/8” casing that was covered in thick iron carbonate scale (FeCO_3) for a live demonstration. FeCO_3 scale is quite hard, and an attempt was made to remove the scale with a hammer and screwdriver, but after several minutes only a very small amount was removed. The entire section of casing was

then cleaned with an EHP tool in approximately 5 minutes (Figure 9).

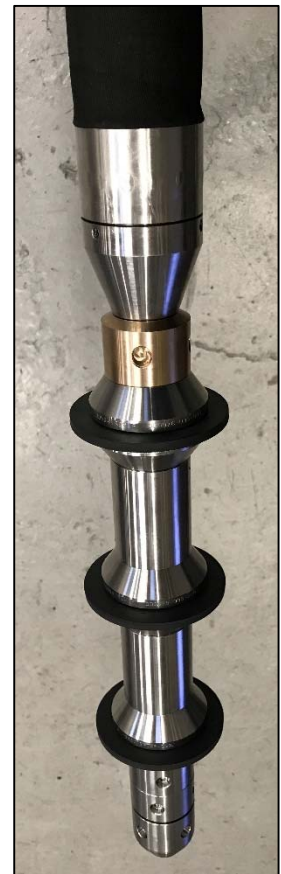
Figure 10. Fluid Hold-Up Tool (FHUT) attached to the bottom of the WASP® tool

Maintaining a column of non-compressible fluid over the EHP tool while it is pulsing is critical to a successful treatment, and the Fluid Hold-Up Tool (FHUT) (Figure 10) was developed to accomplish that, regardless of the fluid in the wellbore. The FHUT is connected to the bottom of the EHP tool and is configurable with multiple rubber disks to seal against the wellbore inner diameter. The size and number of disks are chosen to hold enough of a fluid column (usually water) to cover most of the tool, while minimizing the amount

of drag to allow the tool to travel downhole under its own weight. Tapered washers can be added to increase the stiffness of the disks. When running the FHUT, the usual procedure would be to pump fluid into the well at a small but steady rate, as there will be some fluid leakage past the rubber disks.

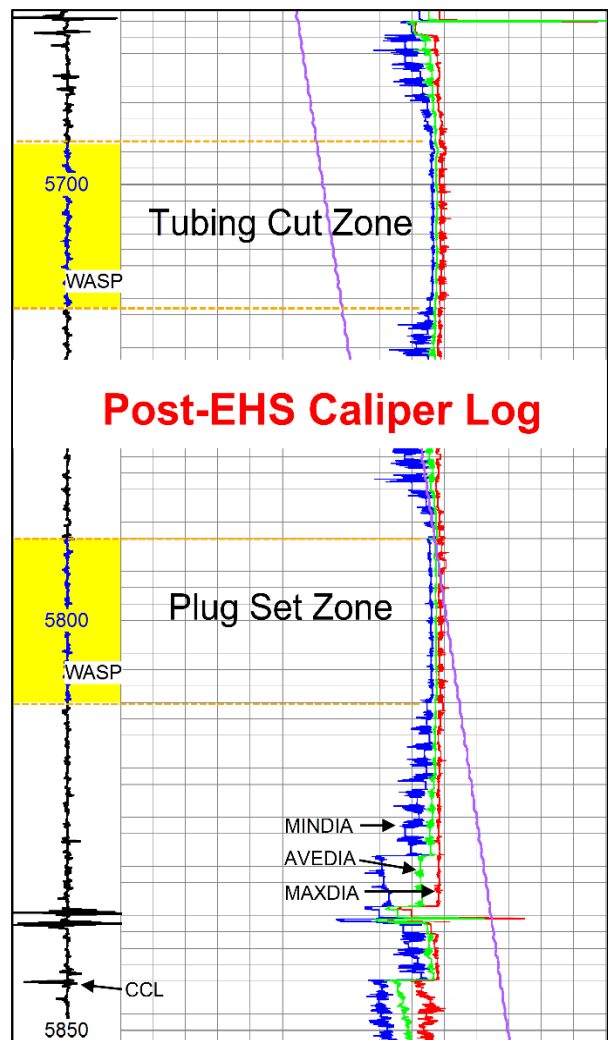
Figure 12. MFC log showing two sections of tubing cleaned by EHP

In a case study involving tubulars in the Danish North Sea, two sections of tubing were required to be cleaned of CaCO_3 scale to be able to do a plug-and-cut, prior to pulling the completion. The customer decided to use EHP for the intervention, rather than waiting for a jack-up rig and using a coiled-tubing unit. The EHP tool successfully cleaned the two sections of tubing, as verified by a multi-fingered caliper log (MFC) (Figure 12). The tubing was successfully plugged and cut in the zones cleaned by EHP. The customer also saved 8 days of jack-up rig time and the cost involved with the rig and a coiled-tubing unit.
